**WATTON NEIGHBOURHOOD PLAN  
DRAINAGE GROUP**

**Preliminary Report to Watton Town Council on Flooding in  
Watton, Proposed Remedial Actions and Possible Sources  
of Funding**

**Presented to the Town Council  
at their meeting  
on 28 November 2017**

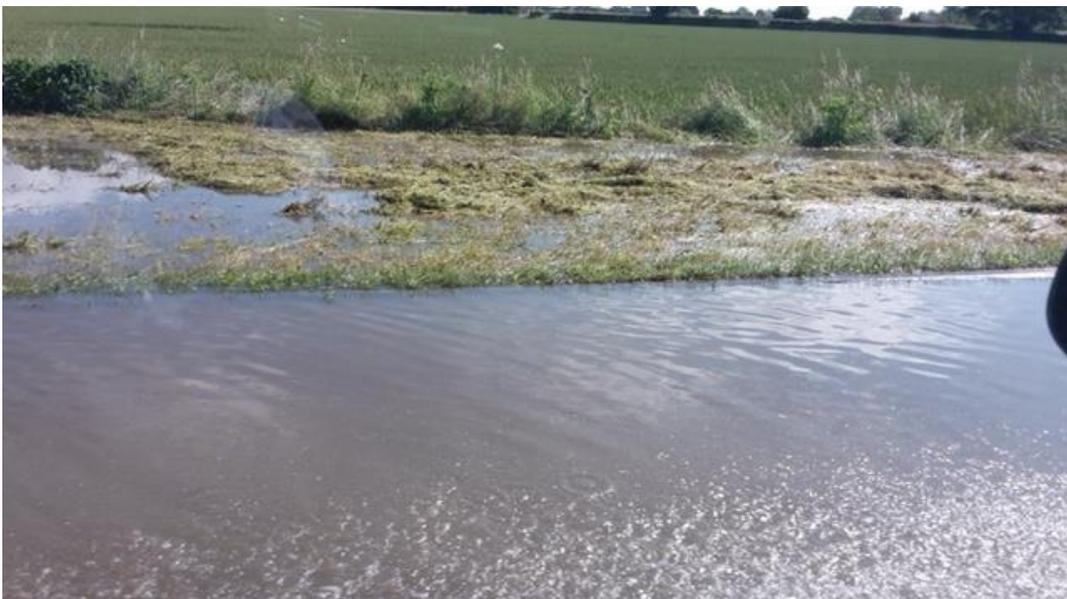
Field behind Canon Close, Barn Ruche Corner June 2016

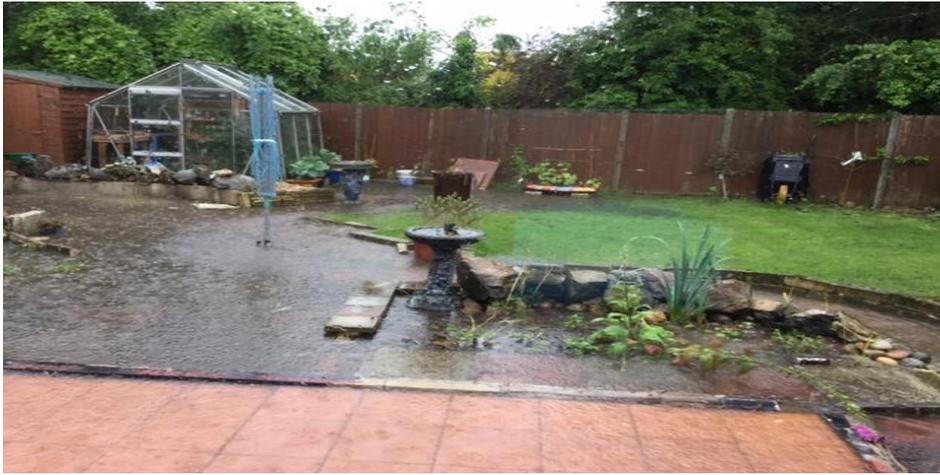
Priory Road

2.9 Without seeing the drainage layout of this estate I can only pass comment on what these photographs and individual reports infer and indicate. I therefore cannot examine how the problem of surface water was dealt with originally because I do not have drawings of the area. The cause might be undersized surface water sewers, sewers that are partially blocked or the lack of proper SUDS built into the design. What we can safely say is, whatever the reason, it allowed surface water to freely cascade over the surface affecting not only dwellings on these areas but along the southern end of Thetford Road also.

2.10 The facts presented to us indicate that whatever method of treatment was used originally it is obviously not working now. Had it been working it is obvious the flooding that occurred on the east side of Thetford Road which flowed across the road onto the Hopkins Homes site opposite would never have happened.

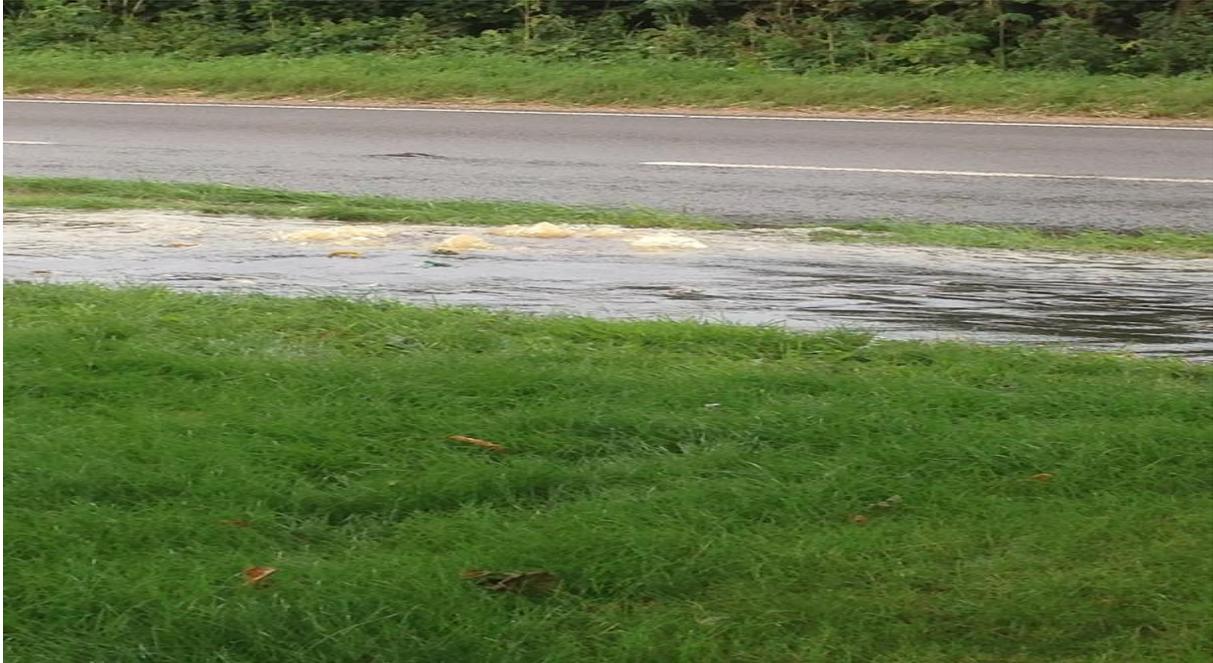
There has been serious flooding caused by the foul water sewer surcharging under storm or high rainfall conditions to the point that it is lifting cast iron manhole covers and flooding out onto the adjoining roads and properties. This occurs regularly and has done so during this year. What has been done and

what has happened over this period is part of another section of this report and dealt with separately below. We will add that this is a sewer that Anglian Water have said is undersized and in need of replacing.

Foul sewer surcharging on Thetford Road

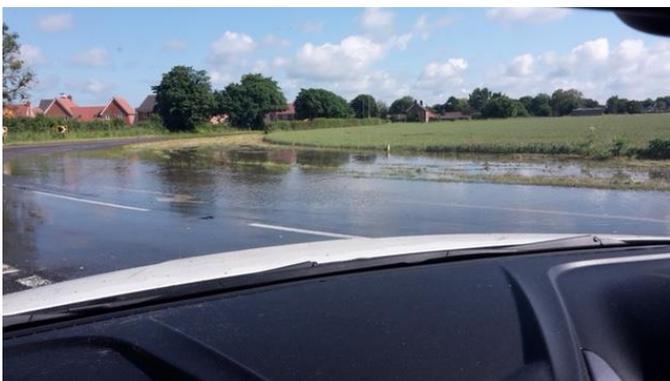
Barn Ruche Corner

Sewerage has flooded at this section of Thetford Road and is possibly part of the same problem above. Sadly we have no written evidence of what has clearly occurred here therefore we cannot comment further until it has been properly investigated. We can only assume it is the same as Part a. Thetford Road West Side above.

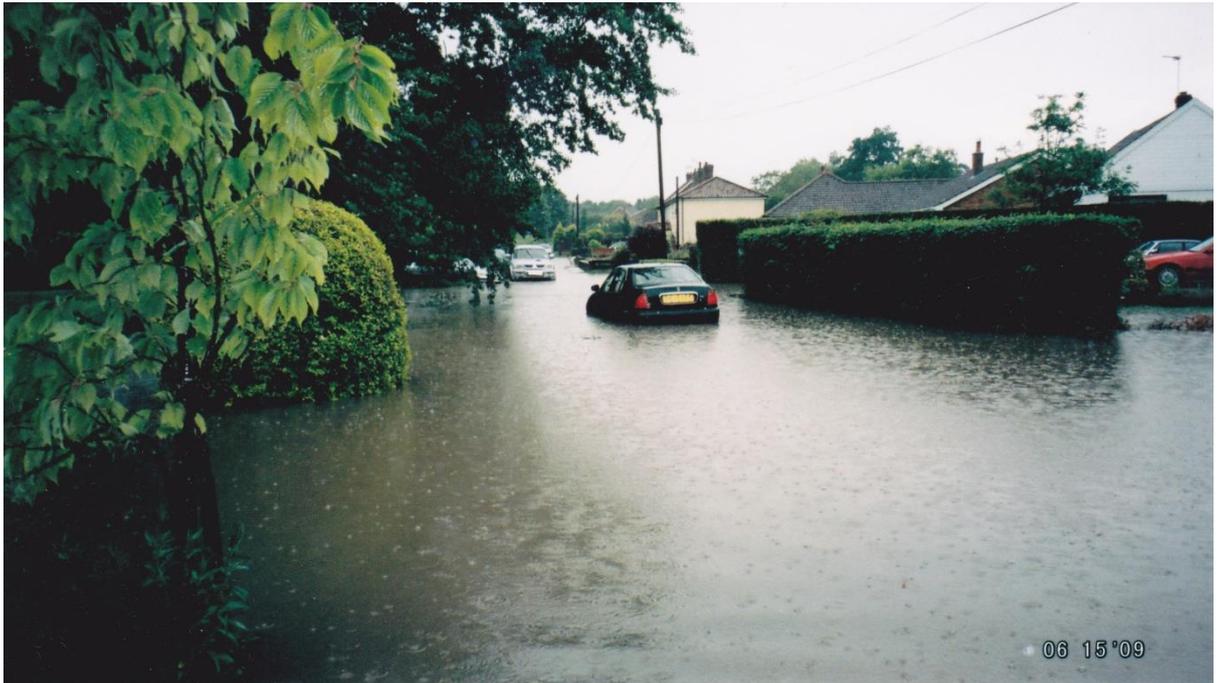
## C. WATTON GREEN.

- 2.13 At this time, the Akrotiri Square and Lovell Gardens sites were being erected. The storm water for these sites ran into the ditch between the Akrotiri site and the field which has now become the Shire Horse Way site. The storm water then entered a manhole in the road in Watton Green to cross the road to another manhole on the north side of the road. Originally there was only one pipe across the road. This was updated over the years to two pipes to cross the road but there is still only one pipe leaving the manhole and two pipes into one does not work, resulting in the road flooding and water flooding into properties and ditches.

- 2.14 Since 1973 the local people have dug a channel from the road into the ditch located on the south side of the road which runs from the properties affected to Rokeles Hall but this fills up very quickly when there is a very heavy downpour.

- 2.15 **Anglian Water sewer.** Around 15-20 years ago, Anglian Water extended the sewer down to Watton Green. This was done in the road and there is a manhole which is sited outside properties 26 and 28. Watton Green has always flooded when it rains and sewerage water floods out of the manhole and into two storm water drains. I have reported this to Anglian Water several times. Their operatives always attend the site and we hear different stories every time ie the pumps have failed, the pumps tripped out, the pumps are not big enough, the pipes are not sealed now when installed. The manhole was

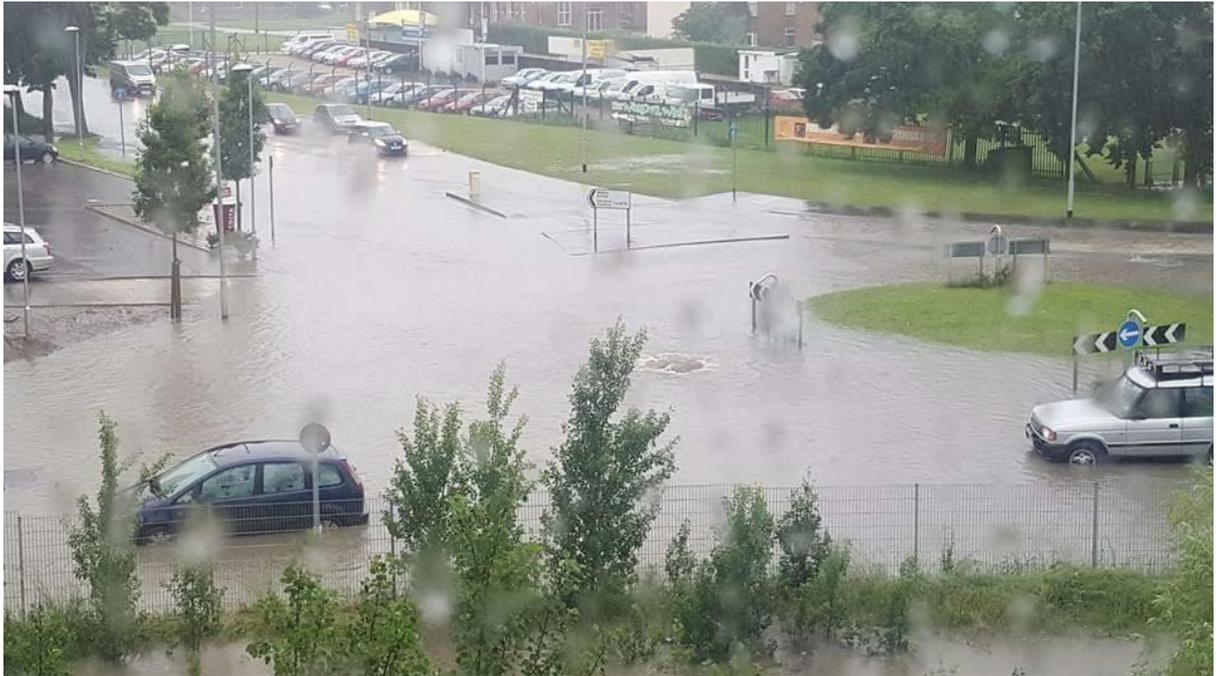
#### D. ROUNDABOUT AT CARBROOKE RETAIL PARADE.

I have only photographs of the extent of the flooding here and no written report. My initial reaction to a possible cause of this flooding is based on how recently the roundabout was constructed and the clear evidence of SUDS incorporated in the lagoon positioned at the southeast side of the roundabout. It is possible that this is undersized and not able to cope with the amount of surface water discharged into it. I don't believe that any blockage would have changed this assumption.

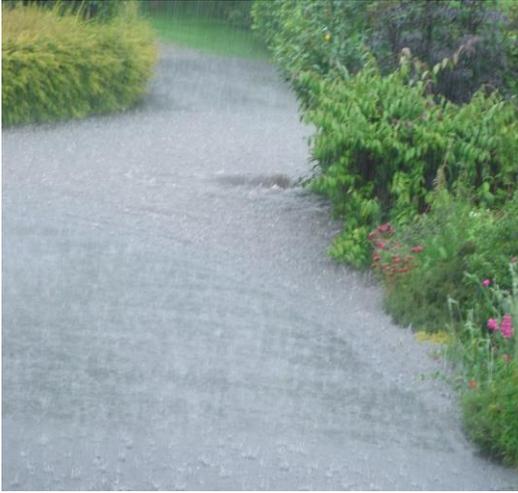
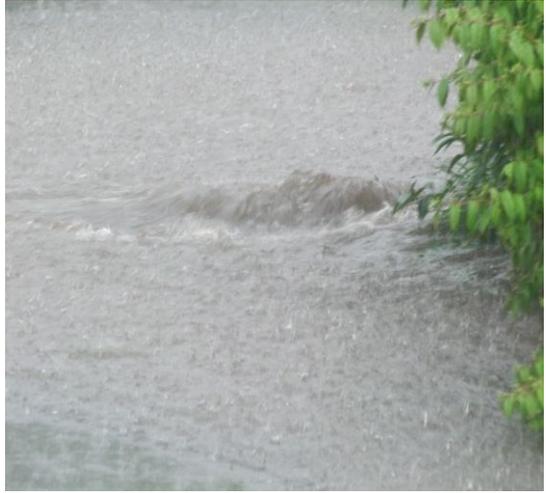
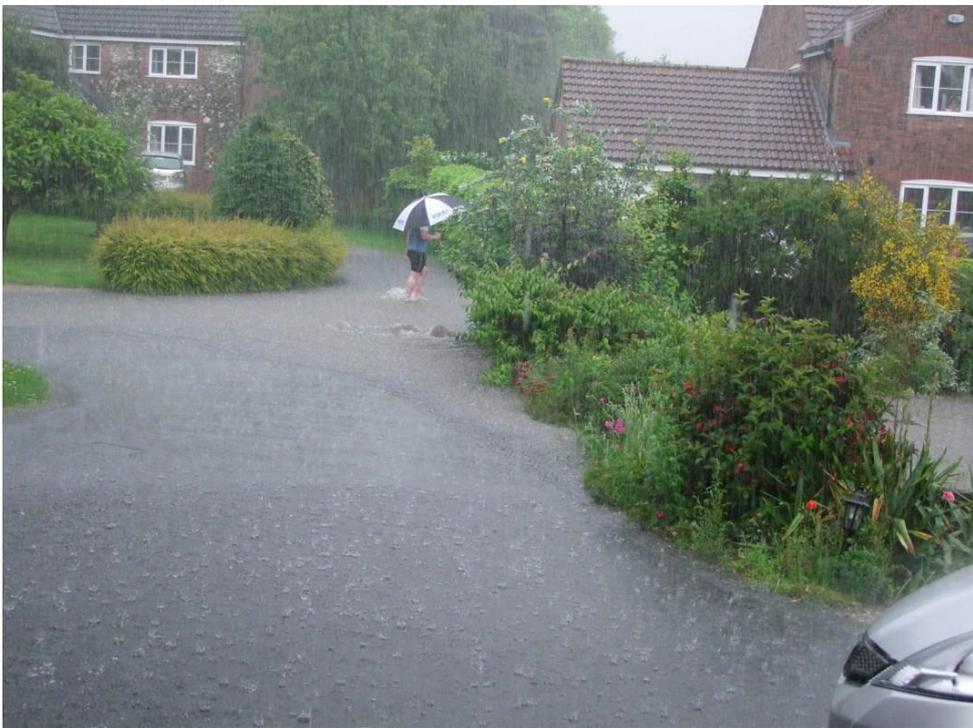
The flooding of Goffe Close and Meadow Grove are interlinked with the surface water sewer that handles Harvey Street and it seems a large part of the town including the High Street.

By Anglian Water's engineers' admittance, the size of the surface water sewer serving these two areas is undersized therefore causing the sewer to surcharge and discharge over these properties at the lower end of the town. The effects of the surcharging caused the flood water to discharge onto adjoining properties including the Charlotte Harvey field, through to properties on Saham Road and beyond. I believe properties on the other side of Saham Road were also affected.

The 'dyke' in the front of No.1 Meadow Grove is clearly of insufficient size to cope with the discharge described above and the passage of water that occurred through to Saham Road. It was suggested that they put a flap-valve at the discharge into the pond. This would not have helped because of the difference in water pressure being higher behind the flap-valve than from the dyke/pond. The other point is that the dyke/pond is full of water which obviously must restrict the amount of surface water that can safely be discharged into it.

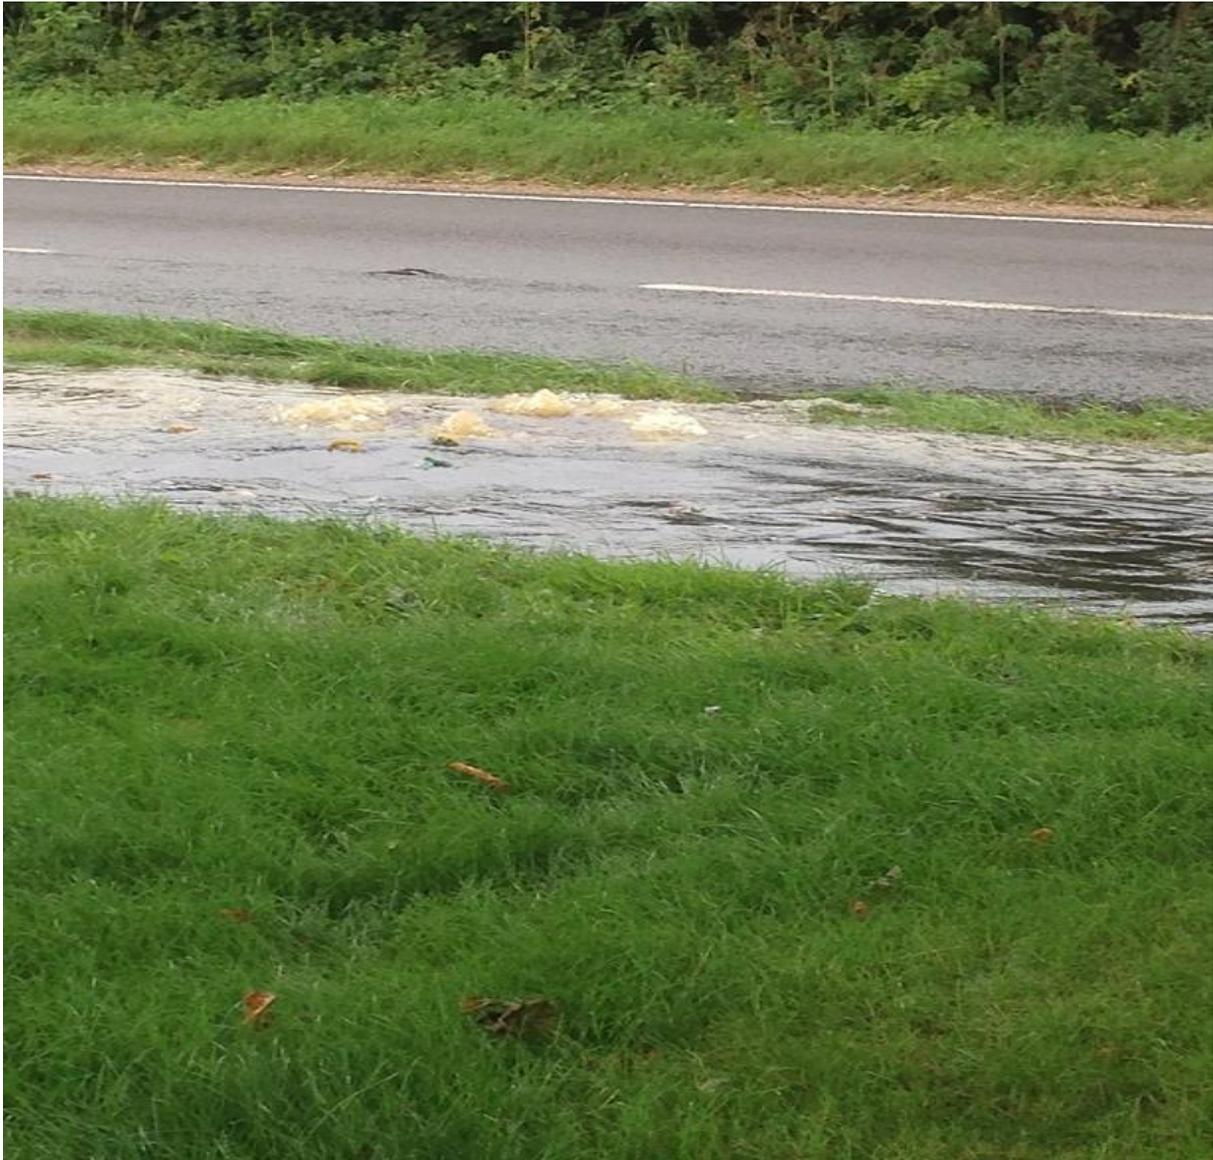
- 3.2 Having moved into our new home on the Hopkins Homes development on November 17<sup>th</sup> 2016 we have suffered with a number of drainage issues where the manhole cover adjacent to our property has overflowed.

Foul sewer on Thetford Road surcharging

- 3.3 This has forced sewerage onto the pavement and our garden and to run down into the main road. Consequently cars driving up the A1075 splashed sewerage onto any persons walking down the pavement and onto our property.

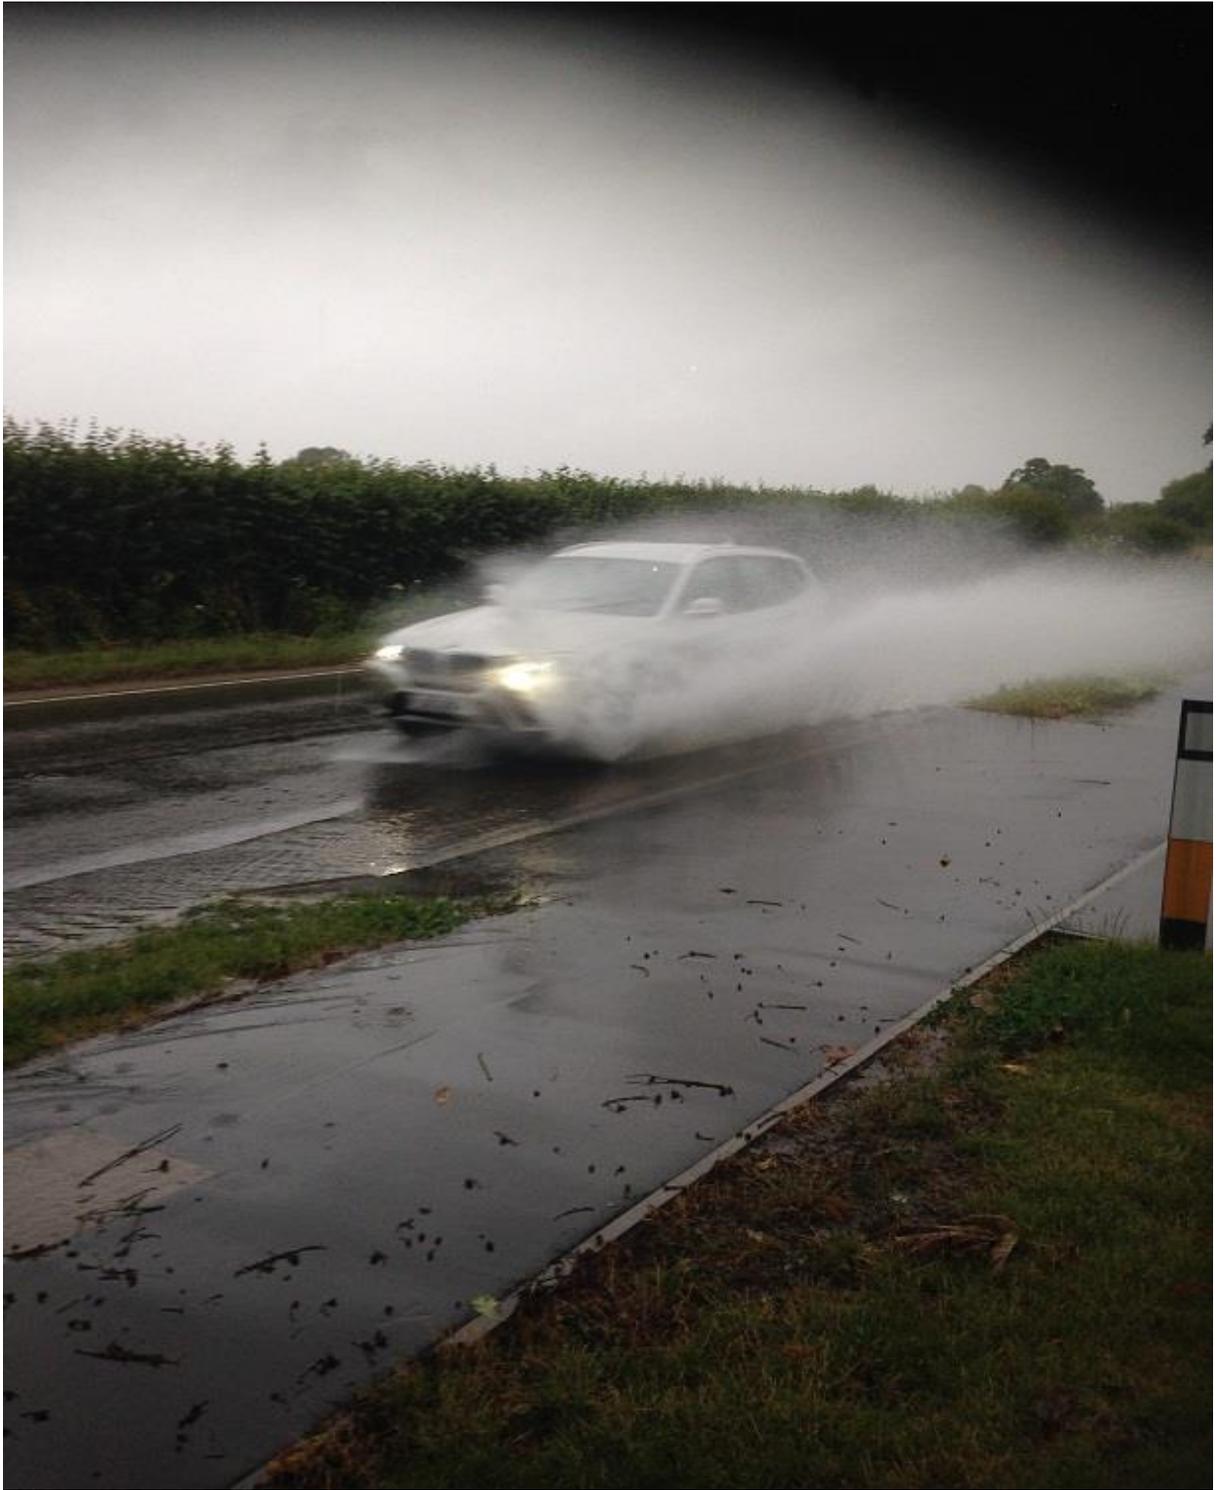
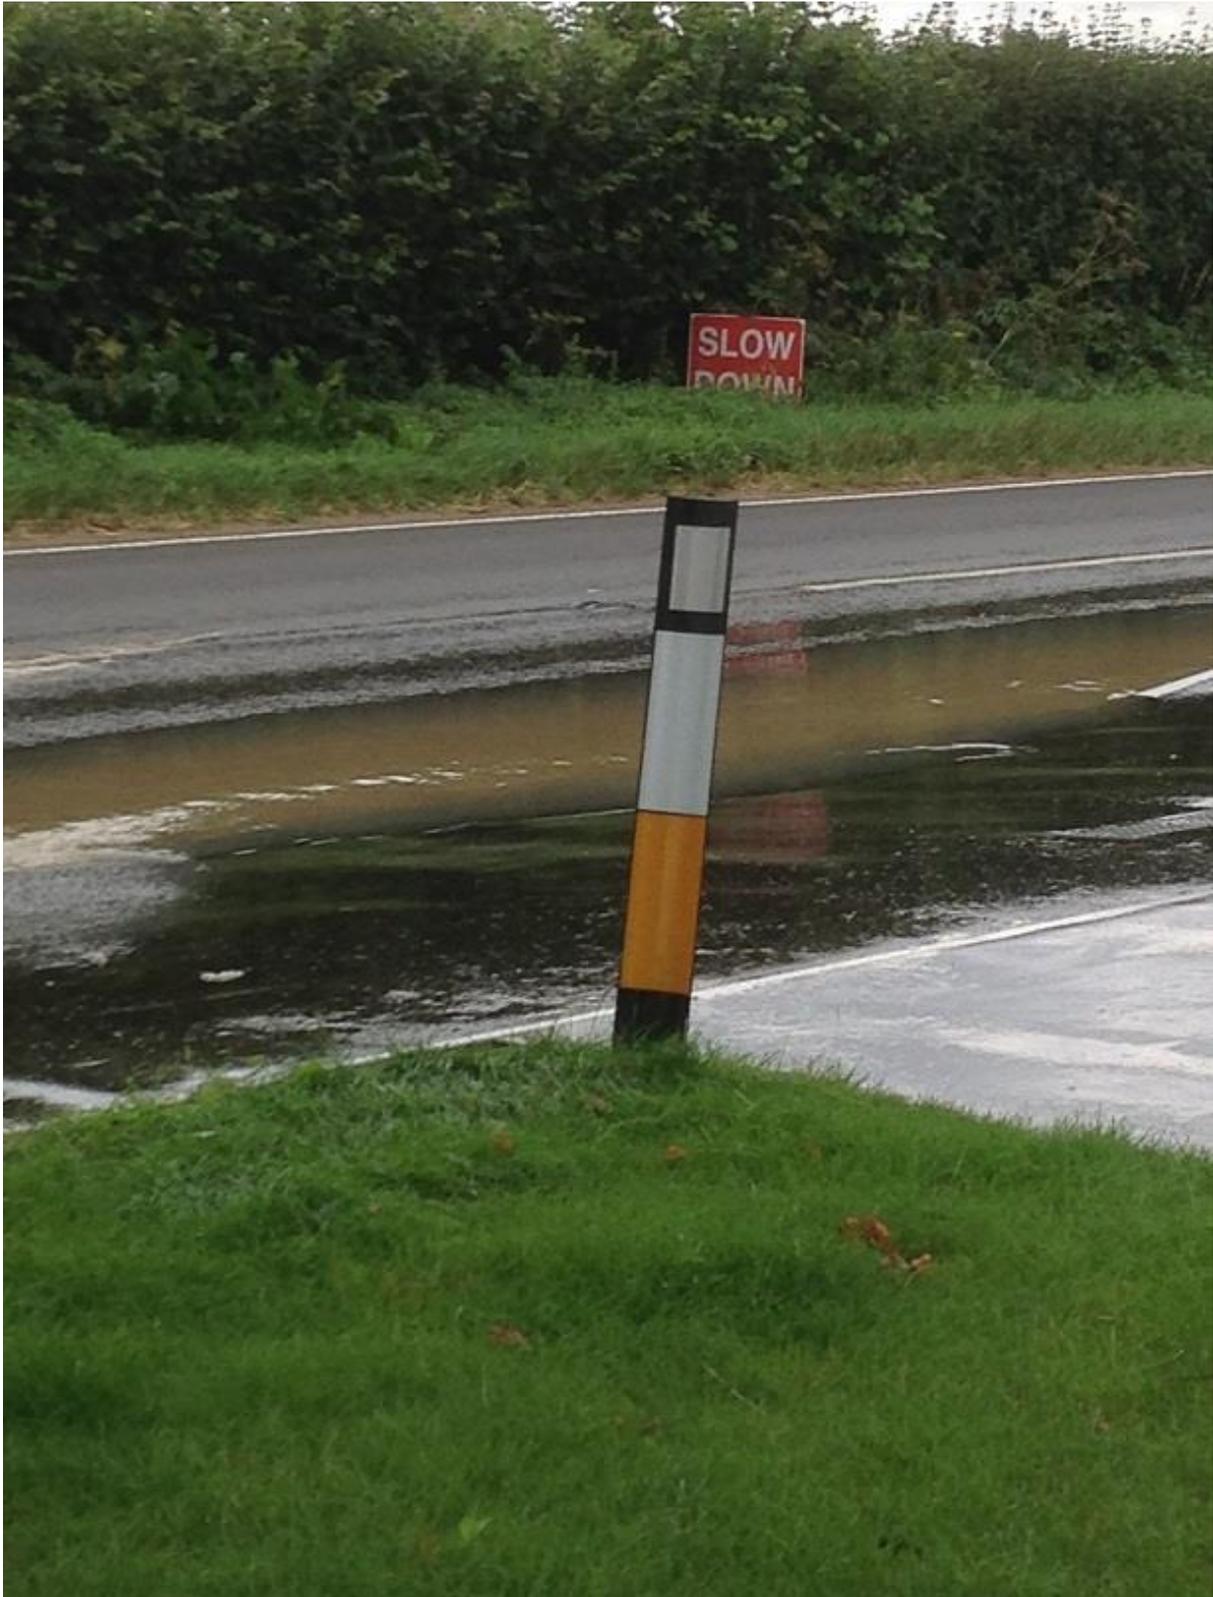
- 3.4 I was advised by the Anglian Water team who attended the first time that the cause was the local Prison where the inmates were placing jumpers and other objects down the toilets although this cannot be confirmed.

- 3.5 On the second occasion the Anglian Water team informed us the reason was the fact that three pumping stations all fed into this drain on the main road and during heavy downpours the amount of water was too great to pass down the pipes along with the sewage from the houses (110 on the estate) and the surface water from the road which all fed into the same pipework.

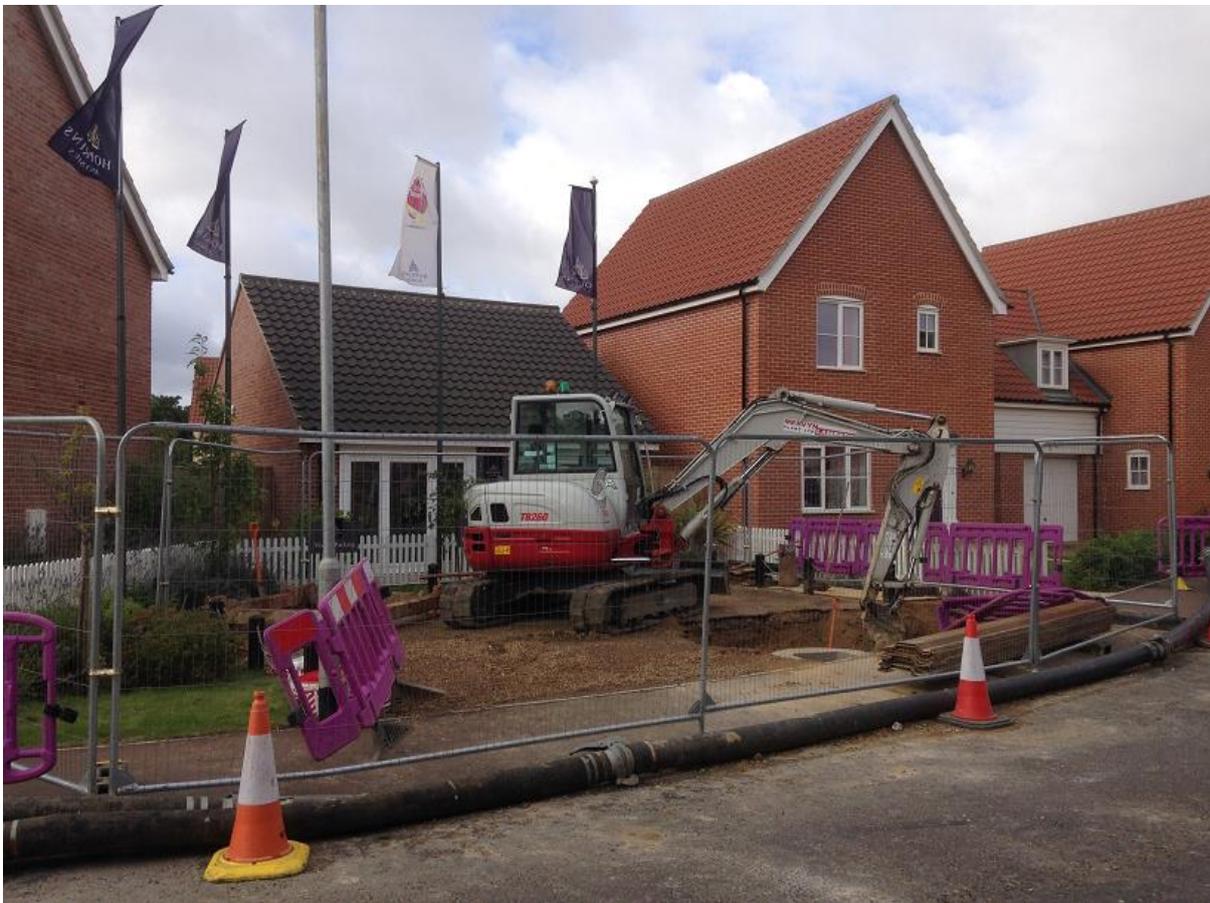
- 3.6 The third and last time we suffered the now familiar sewerage entering our garden, pavement and main road, the team from Anglian Water found that a drain had collapsed on the Hopkins Homes site and they had to “over pump” past the blockage whilst they dug up the collapsed drain and replaced it with a new manhole and new pipework. They (Anglian Water) have assured me this has rectified the problem and the sewerage will not “leak” onto the pavement and my property anymore. This will remain to be seen and myself and wife check the drain every time it rains hoping the sewerage does not return.

Anglian Water over pumping past the collapsed drain

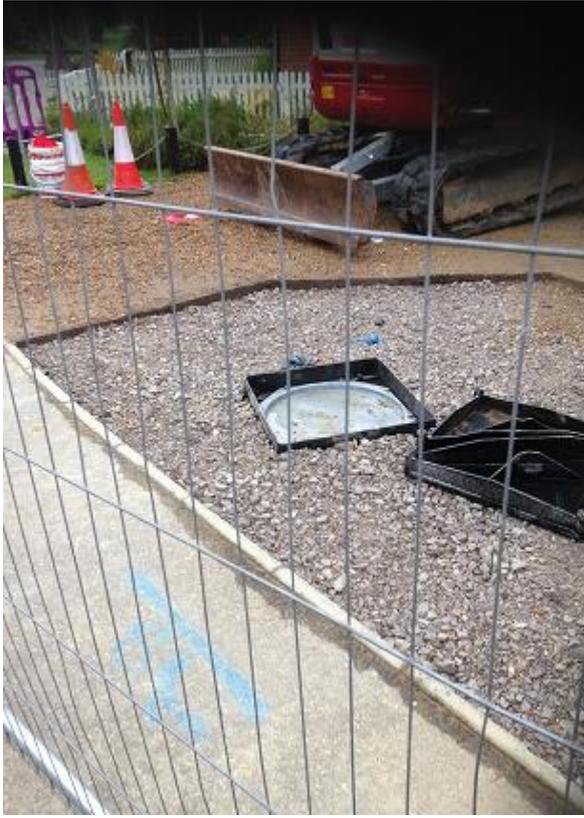
- 3.7 From memory we have suffered this at least 5 times since last November.
- 3.8 Out of interest Anglian Water fitted a manhole cover which has a bolted down lid when they repaired the drain. I asked Anglian Water if they could replace the drain cover outside our property with the same type of cover, so we would not suffer this problem again but was told this cover was fitted in error and

had nothing to do with the fact that this cover is situated in the parking spaces of the show home!
